# INVITATION FOR BID # 21-06

### COMMODITY: Building Demolition (Multiple Locations)

## LIMITED REGULATED MATERIALS AND INDOOR AIR QUALITY SURVEY REPORT

**Historic Phlegar Building**  
4 South Franklin Street  
Christiansburg, Virginia 24073

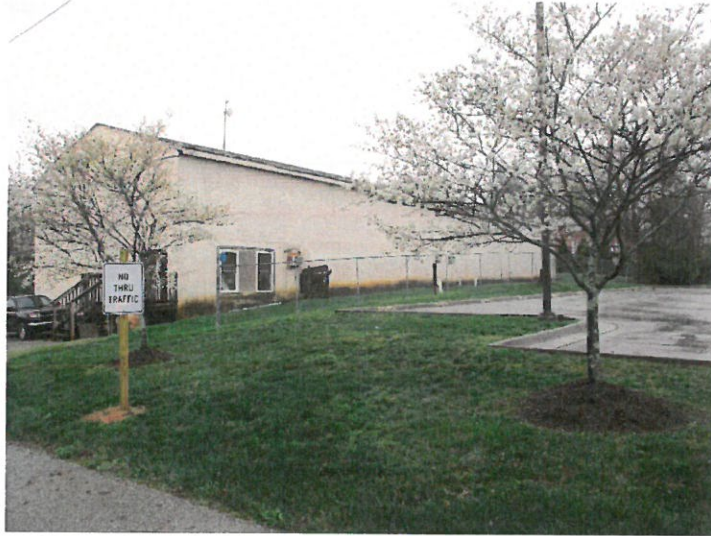
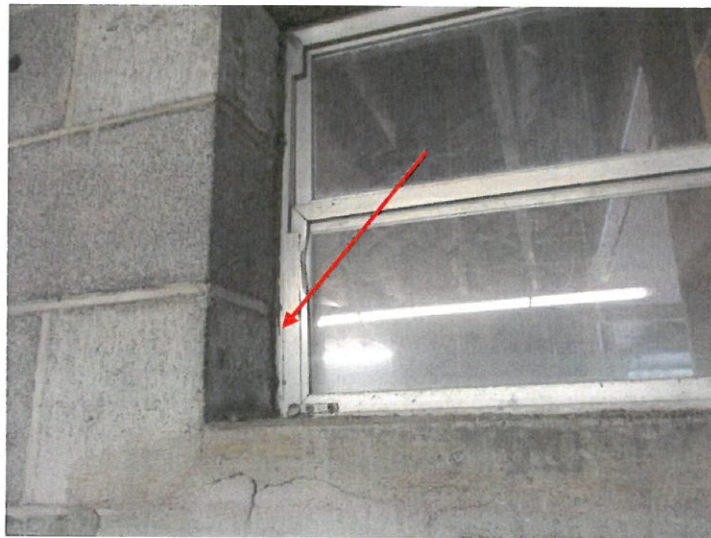
## Town Shop Reading Road

**The interior window framing was found to be Asbestos  
Containing by the laboratory.**

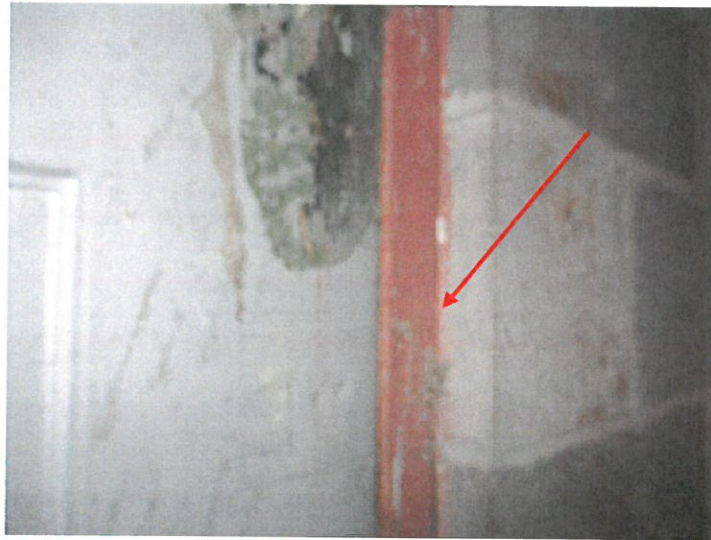
## Town Shop Reading Road

**The interior door framing was found to be Asbestos Containing by the laboratory.**

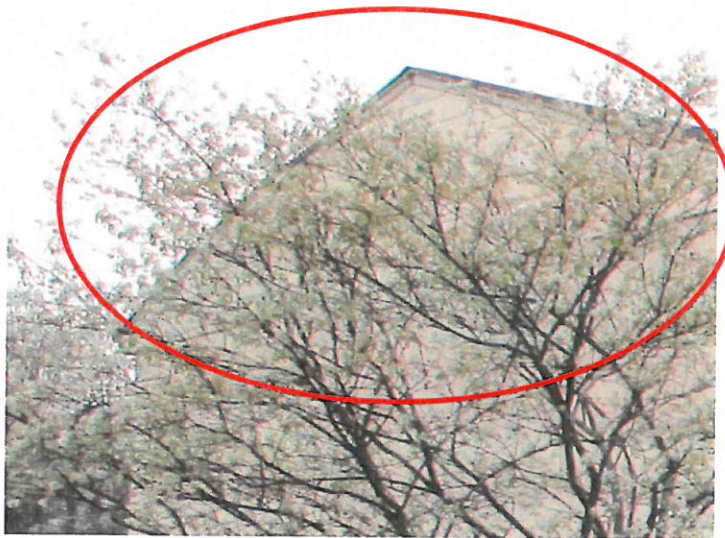
**The transite siding located on the building gables was found to be Asbestos Containing by the laboratory.**

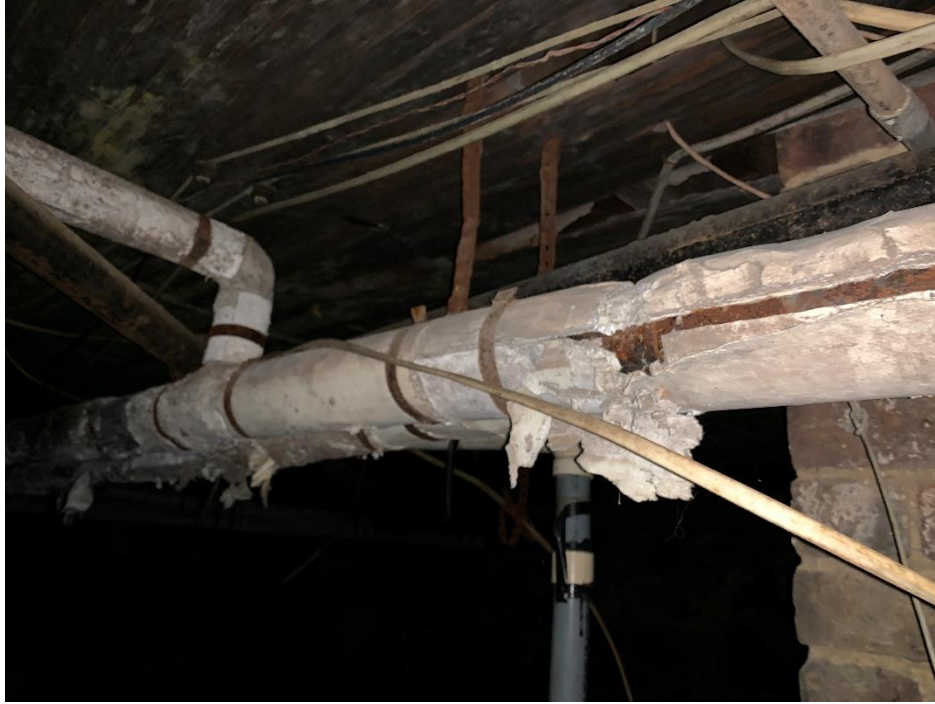
View of asbestos containing air cell pipe insulation located in the basement of the structure

Prior to any activities that will impact the ACM, F&R recommends that the identified ACMs be appropriately removed, handled, and disposed of by an appropriately licensed/accredited Abatement Contractor utilizing appropriately licensed/accredited personnel.

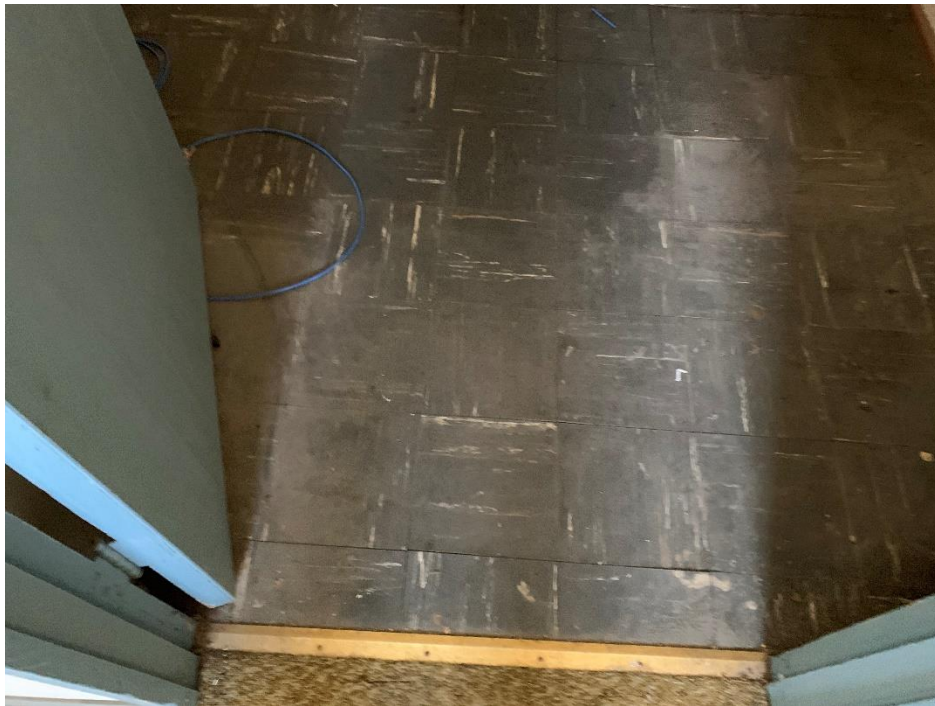
View of asbestos containing 9x9 Floor Tile in the first floor bathroom 1

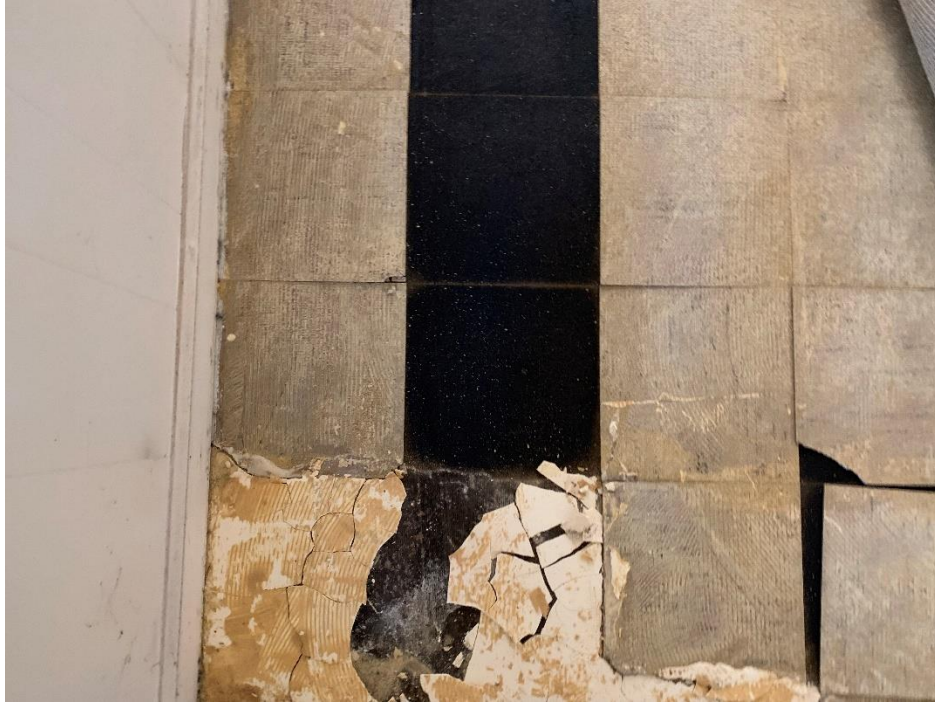
View of asbestos containing 9x9 vinyl floor tile located in the hallway of the second floor underlying carpet

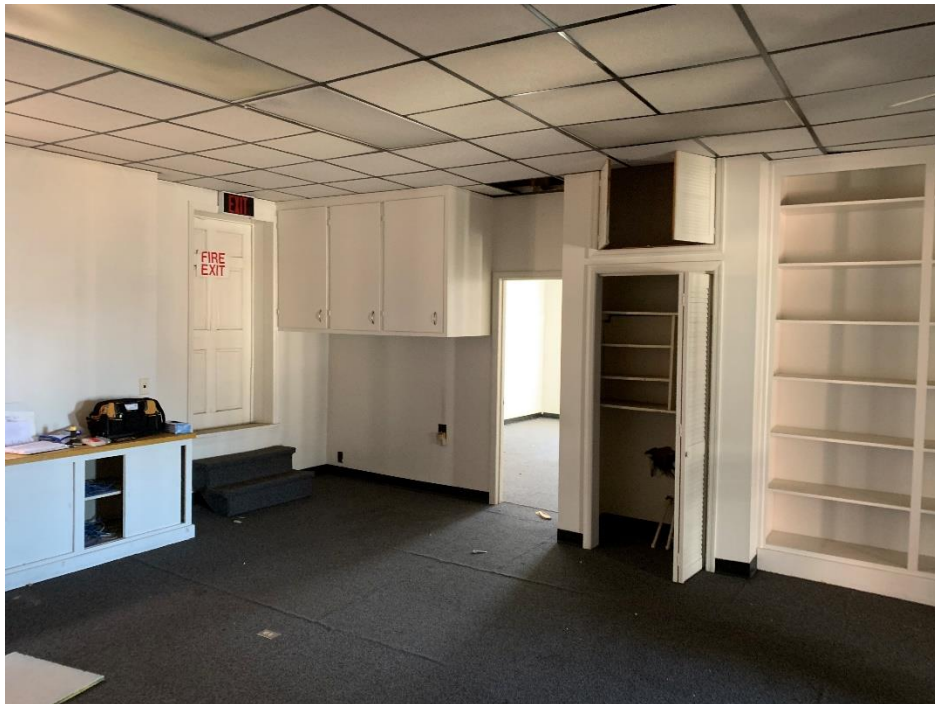
View of the second floor lobby. Note that asbestos containing sheet vinyl backing was identified underlying carpet and fiber board

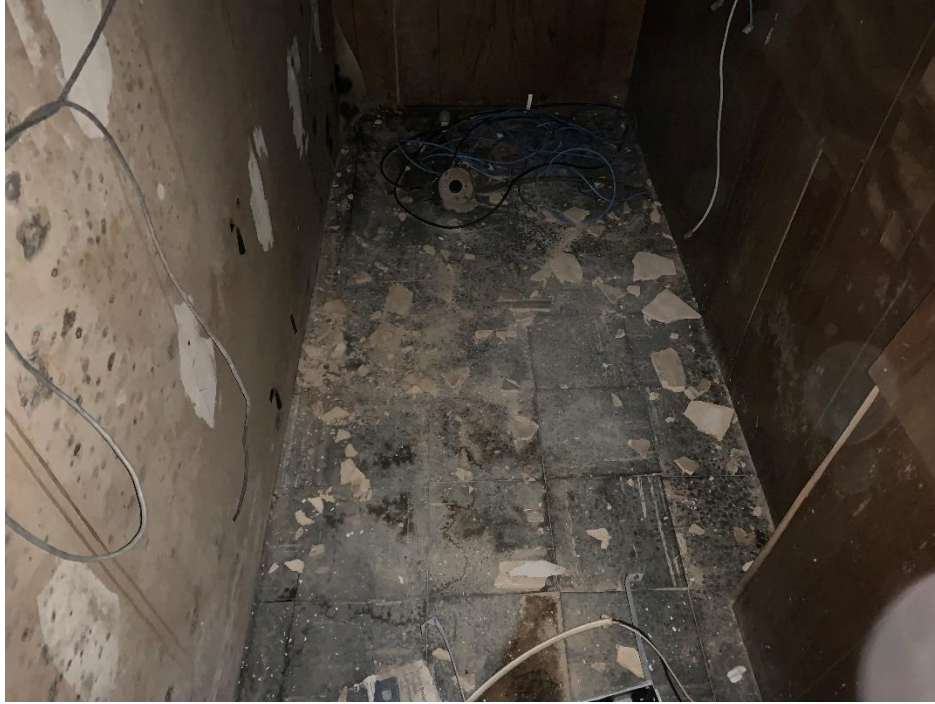
View of asbestos containing 9x9 vinyl floor tile in the magistrate office

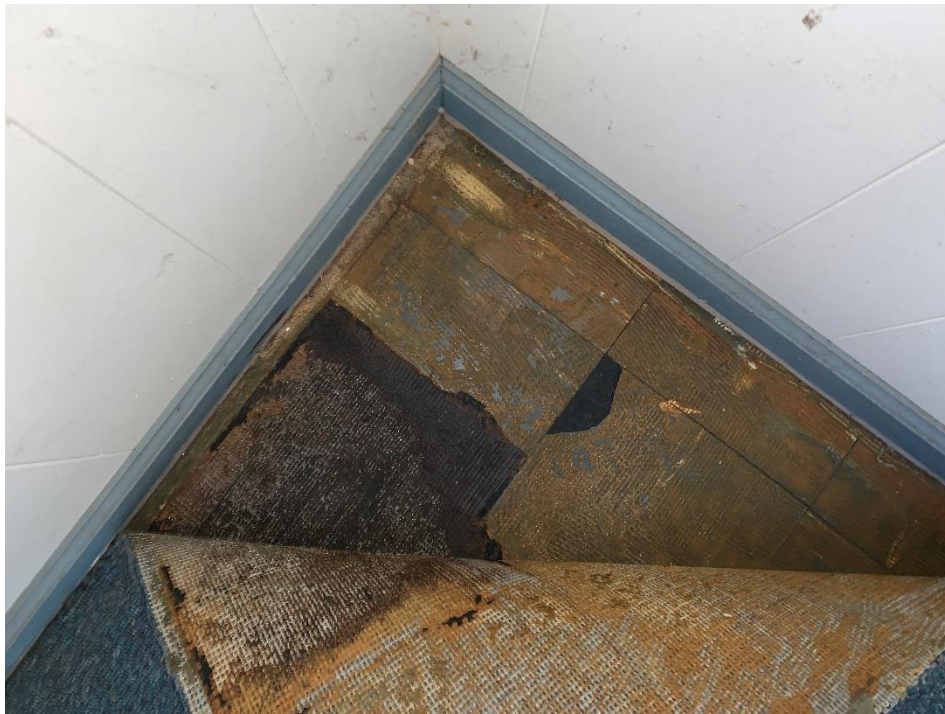
View of asbestos containing vinyl floor tile which underlies carpet in office 4 of the first floor

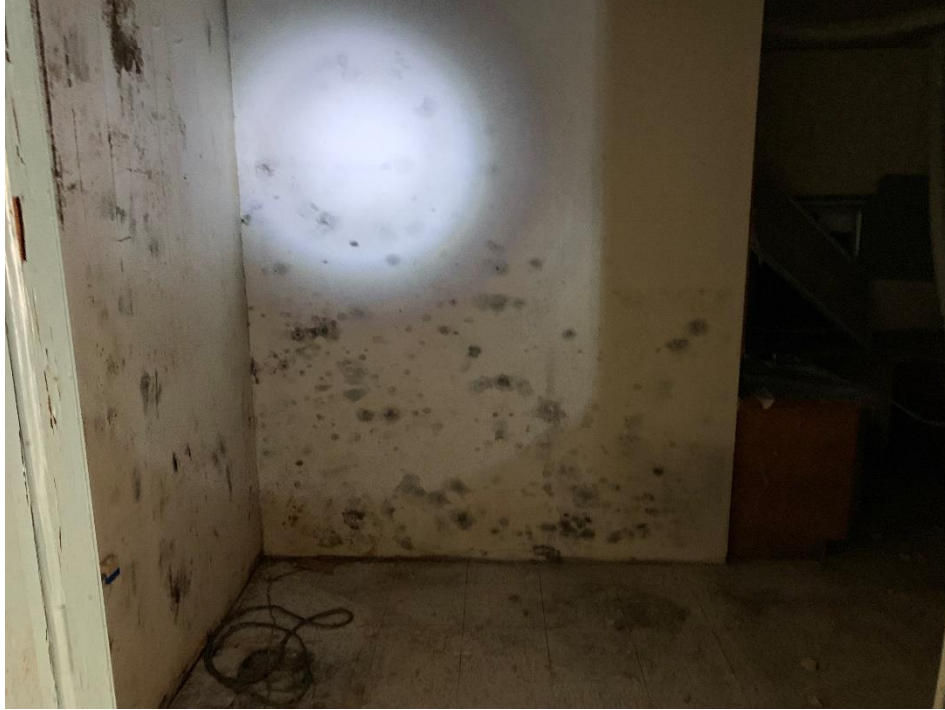
Heavy visible suspect mold growth was present on walls and ceiling materials throughout the first floor magistrate office. Mold growth is likely attributed to an increase in moisture content from a past water leak. The source of the water intrusion was not readily apparent during the assessment.

View of mold growth on wall of magistrate office

1. Based on the extent of mold growth, F&R recommends that remediation efforts be performed. Remediation should be performed in general accordance with the guidelines described in EPA's September 2008 document "[Mold Remediation in Schools and Commercial Buildings](#)" and the attached General Remediation Procedures Guidelines. Based on the amount of mold present, maintaining a negative pressure environment in the work area is warranted and response actions should accord with the recommendations for large areas of growth noted in Table 2 of the referenced document. These efforts should be concentrated on materials where visible mold growth is apparent.

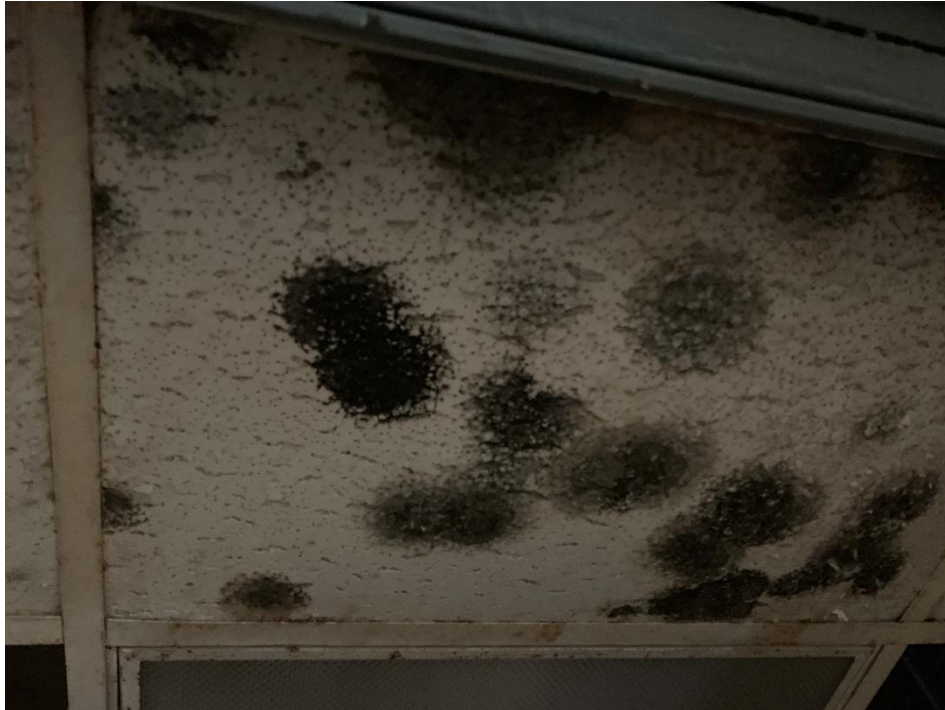
View of mold growth on ceiling tile of magistrate office
